66 Westgate Street - Hedley's

Construction of 66 Westgate Street

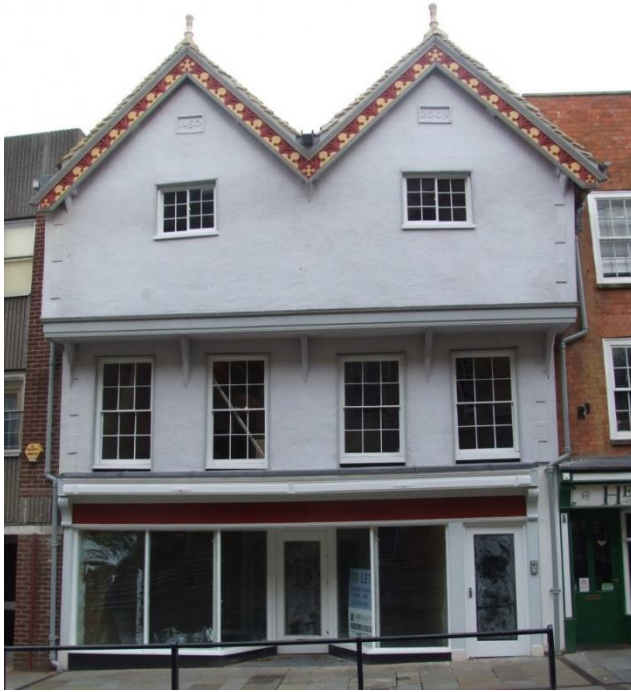
66 Westgate Street is a timber framed building on the north side of Westgate Street close to the Cathedral. It stands just inside the west gate to the city on one of the principal thoroughfares into the centre of medieval Gloucester. Occupation of such an important site would indicate that its

builder had considerable means and the quality of its construction is indeed proof that this was a building of high status.

The Victorian ground floor windows are an early example of large plate-glass made possible by the technology gained in building the Crystal Palace, London for the Great Exhibition in 1851.

The windows on the first floor were inserted in the eighteenth century.

A thorough restoration of the building was completed in 2009 and the decorated gable storey now resembles its original medieval appearance.
